Shoreline and Riparian Condition Assessment

Kneehill County

June 2023

Your Shoreline and Riparian Condition Assessment

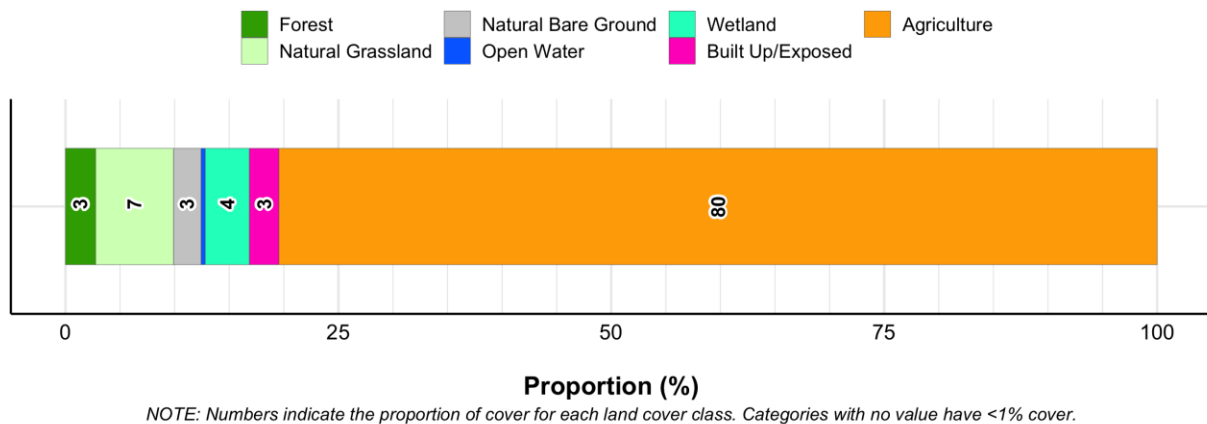
Figure 36. The proportion of Kneehill County assigned to each land cover class. Land cover data is based on the 2020 Agriculture and Agri-Food Canada land cover.

Kneehill County overlaps both the Kneehills and Threehills subwatersheds, with 94% of the county being covered by these two subwatersheds (Map 4). Agriculture is the predominant land cover in this county (80%), with natural cover accounting for approximately 17% of the land cover (Figure 36). Natural grassland (7%) and wetland (4%) make up the greatest proportion of natural cover, with this cover tending to be associated with the southern portions of Kneehills, Threehills, and Ghostpine Creek.
