# Shoreline and Riparian Condition Assessment

## **MD of Bighorn**

Summer 2023

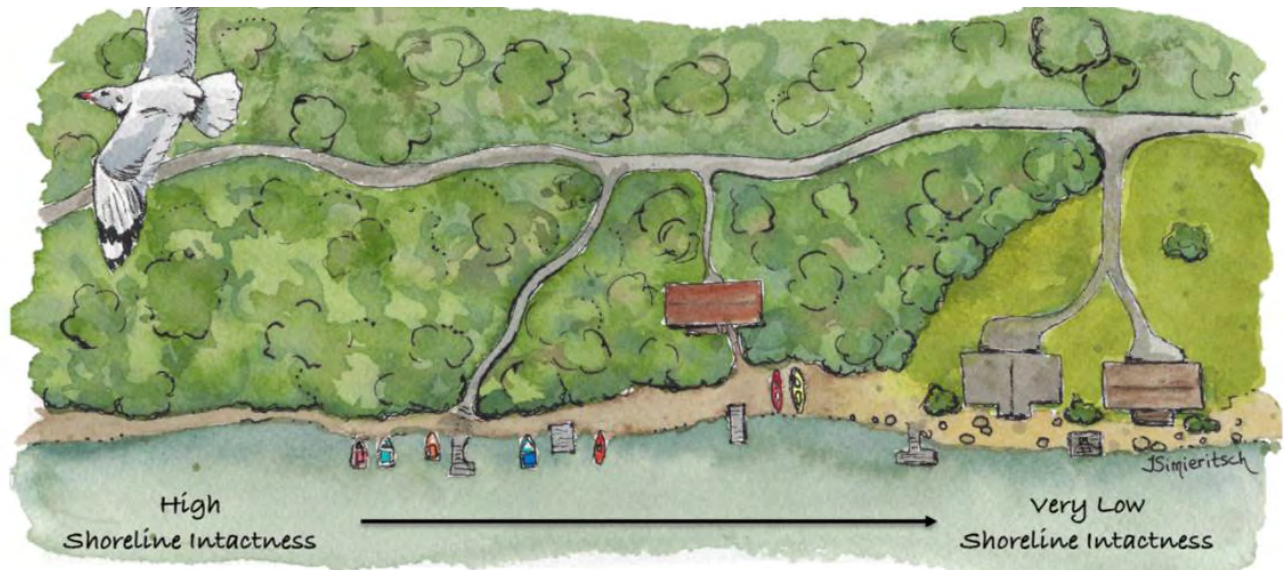
Riparian intactness is a measure of how “natural” a shoreline is. Riparian intactness measures riparian condition at a broad scale, using satellite data. This is a new method, which has been scientifically validated, to assess riparian conditions across a large area in Alberta.

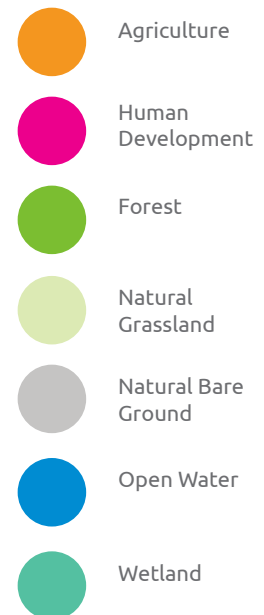
*Map 1: Land Cover in the municipality. This is based on the AAFC's Land Class data (2021). The resolution for these datasets is coarse, so this is a general representation of Land Cover in the*

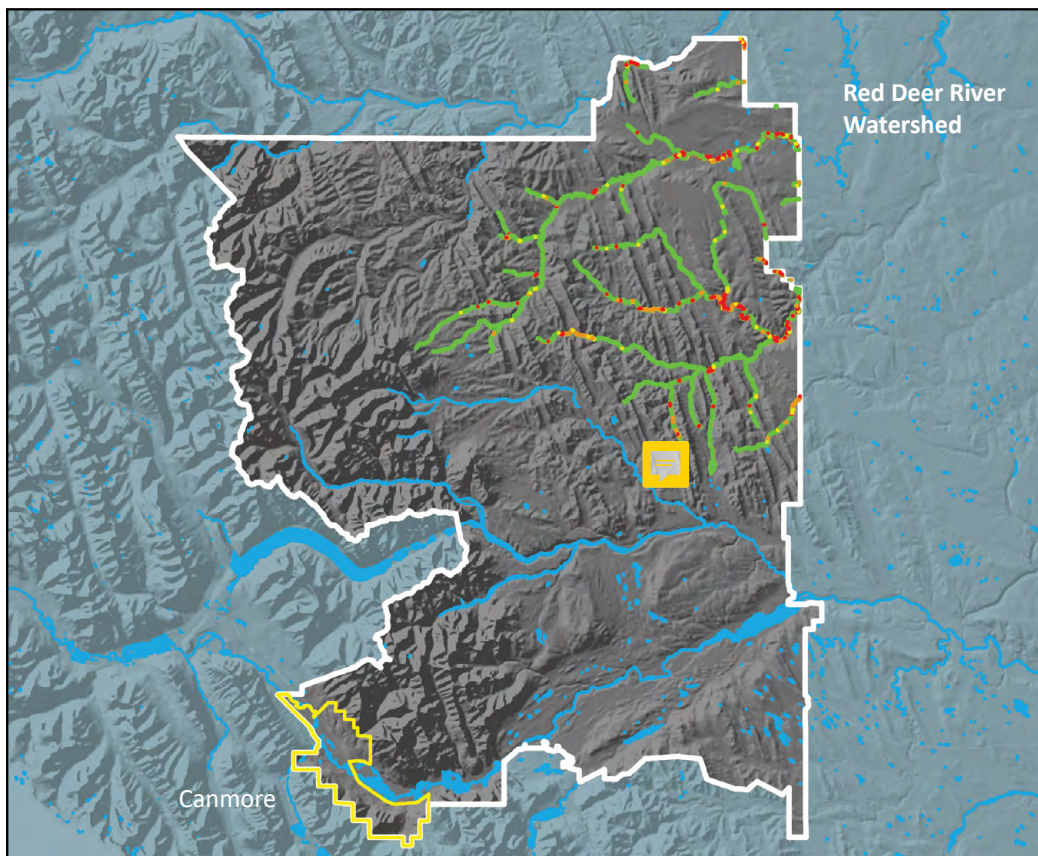
**Map 2: Riparian Intactness in the municipality.** Note: It was not possible to assess some areas. To view more data, please see the attached [Appendix](#).

**647 KM**

of shorelines assessed  
in MD of Bighorn

**9/9**

\* lakes had 65%+  
**High Intactness**

**20/21**

\* creeks had 65%+  
**High Intactness**

- Vegetation mostly cleared. Human footprint dominant.
- Vegetation limited. Human footprint prevalent.
- Vegetation present. Some human footprint.
- Vegetation present. Little or no human footprint.

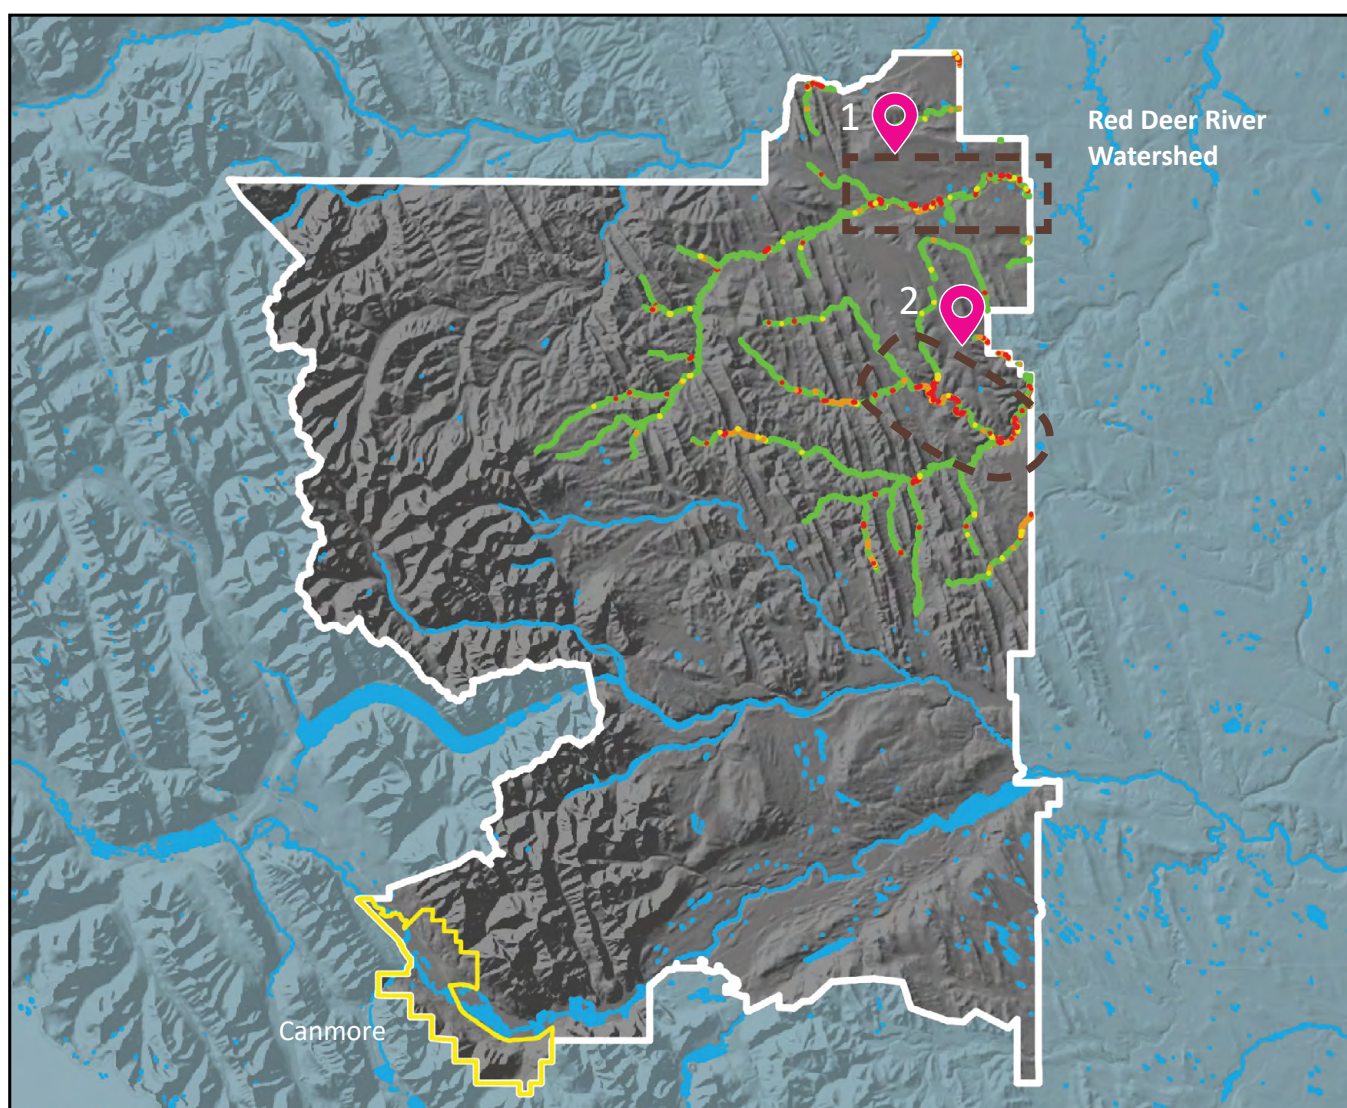
*Map 3: Key Areas for Conserving or Restoring Riparian Areas Based on Intactness.*

- 1 Confluence of Fallentimber Creek and Stormy Creek and lower reach of Fallentimer Creek.
- 2 Confluence of Grease Creek and Turnbull Creek. Lower reaches of Grease Creek and Little Red Deer River.

Continue to conserve most other areas, which have high intactness

Areas with the lowest intactness need restoration

Areas with the highest intactness need conservation

- 1 Use priority maps to direct conservation and restoration efforts.
