# Shoreline and Riparian Condition Assessment

## **Mountain View County**

Summer 2023

## 9.4. Mountain View County

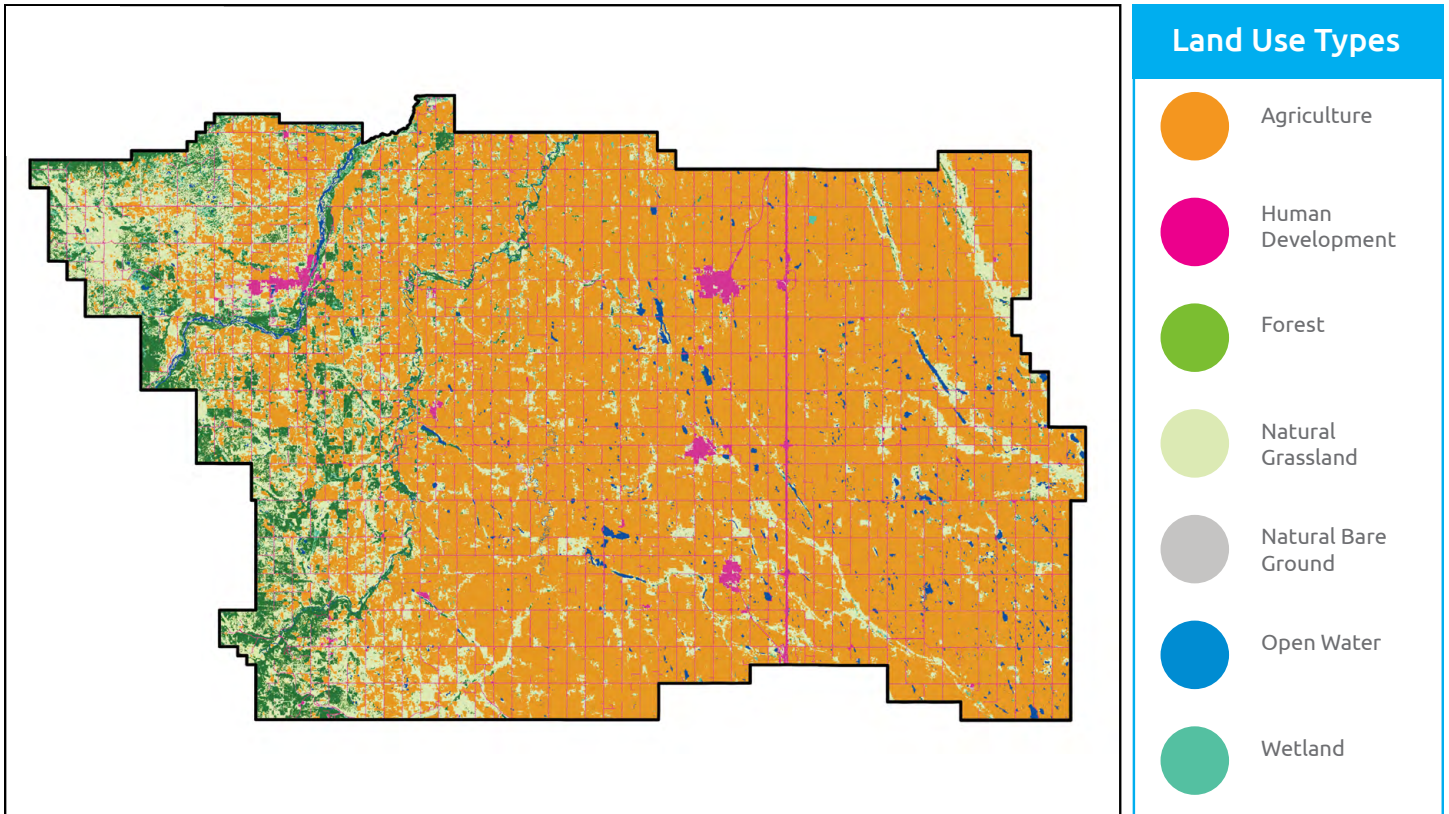
*Map 1: Land Use in the municipality. This is based on the AAFC's Land Class data (2021). The resolution for these datasets is coarse, so it provides a general representation of land use in the area.*

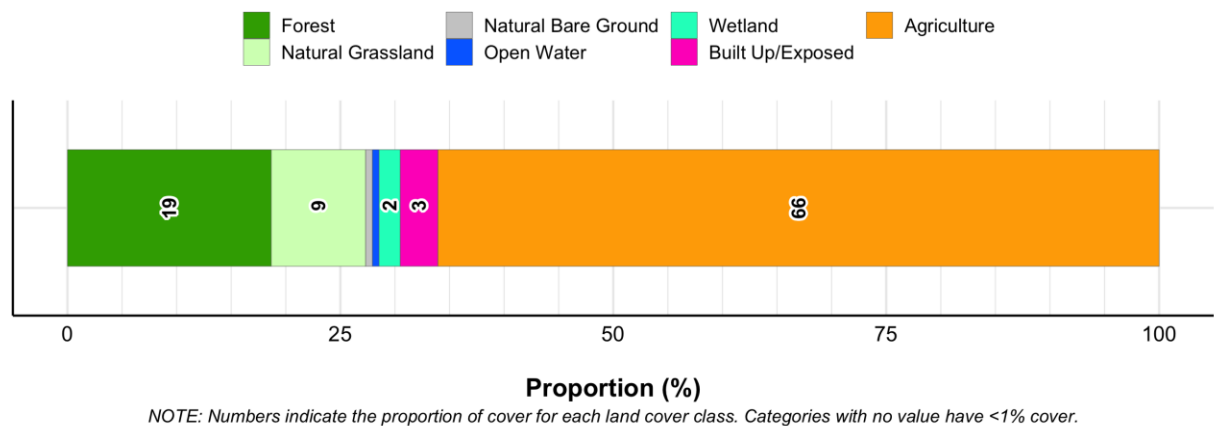
Figure 46. The proportion of Mountain View County assigned to each land cover class. Land cover data is based on the 2020 Agriculture and Agri-Food Canada land cover.

Mountain View County overlaps both the Little Red Deer and Kneehills subwatersheds, with 71% of the county being covered by these two subwatersheds (Map 4). The majority of the land cover in this county is agriculture (66%), with natural cover accounting for 31% of the cover (Figure 35). Forest and natural grassland make up 19% and 9% of the land cover, respectively, with this cover tending to be associated with the western portions of the county. Agriculture is the predominate land cover in the central and eastern portions of the county.

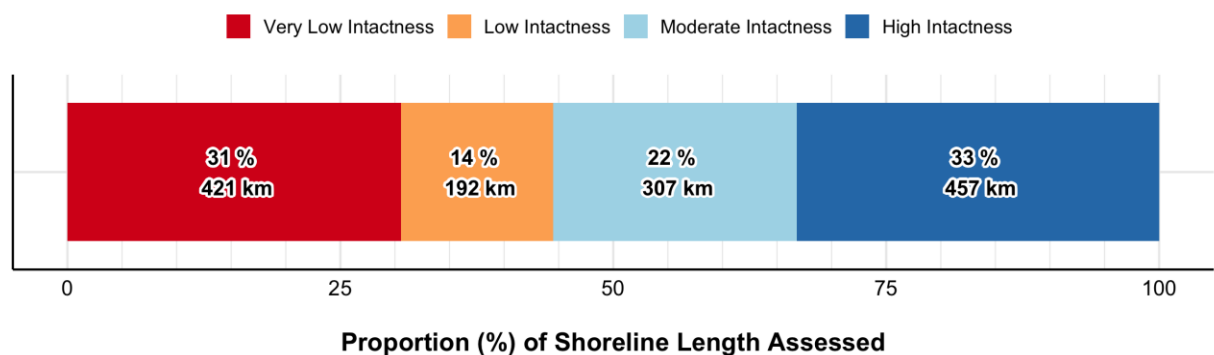
Figure 47. Overall intactness for waterbodies assessed within Mountain View County.

A total of 1,377 km of shoreline was assessed within Mountain View County with 33% (457 km) categorized as High Intactness and an additional 22% (307 km) assessed as Moderate Intactness (Figure 47). The remaining 45% of shoreline was categorized as Low Intactness (14%, 192 km) or Very Low Intactness (31%, 421 km). These results included both the left and right shorelines of watercourses.

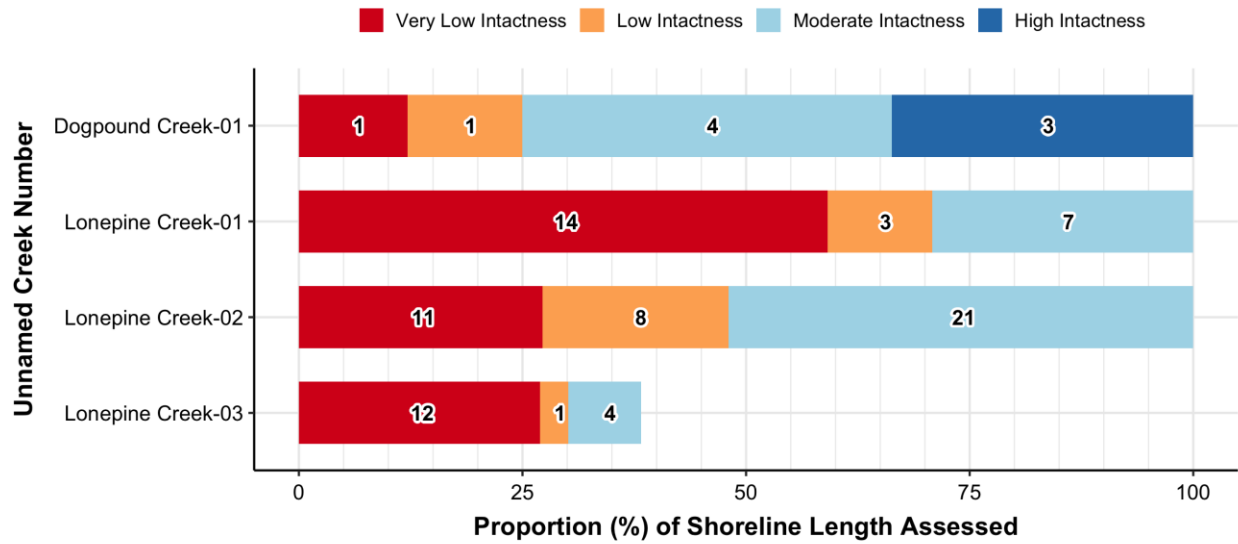
NOTE: Numbers indicate the total length (km) of shoreline associated with each intactness category.

Figure 48. The proportion of shoreline length assigned to each riparian intactness category for unnamed watercourses within Mountain View County.

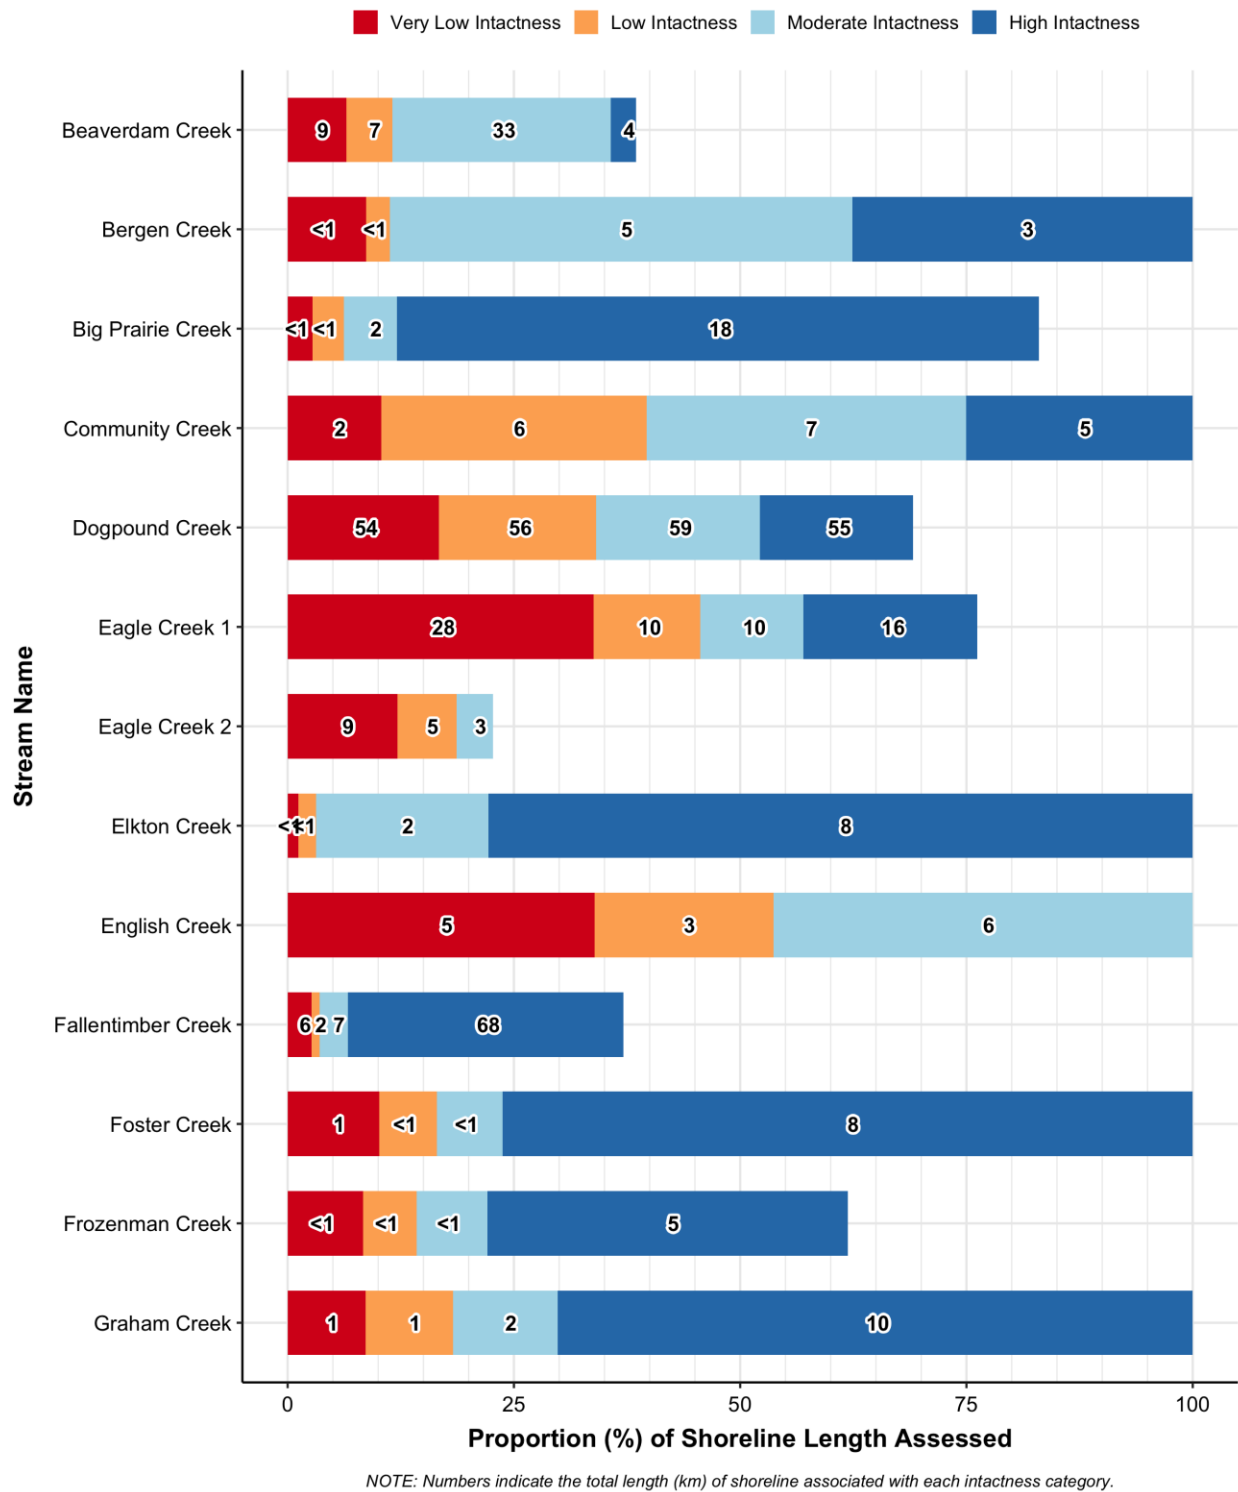
Figure 49. The proportion of shoreline length assigned to each riparian intactness category for named watercourses within Mountain View County.

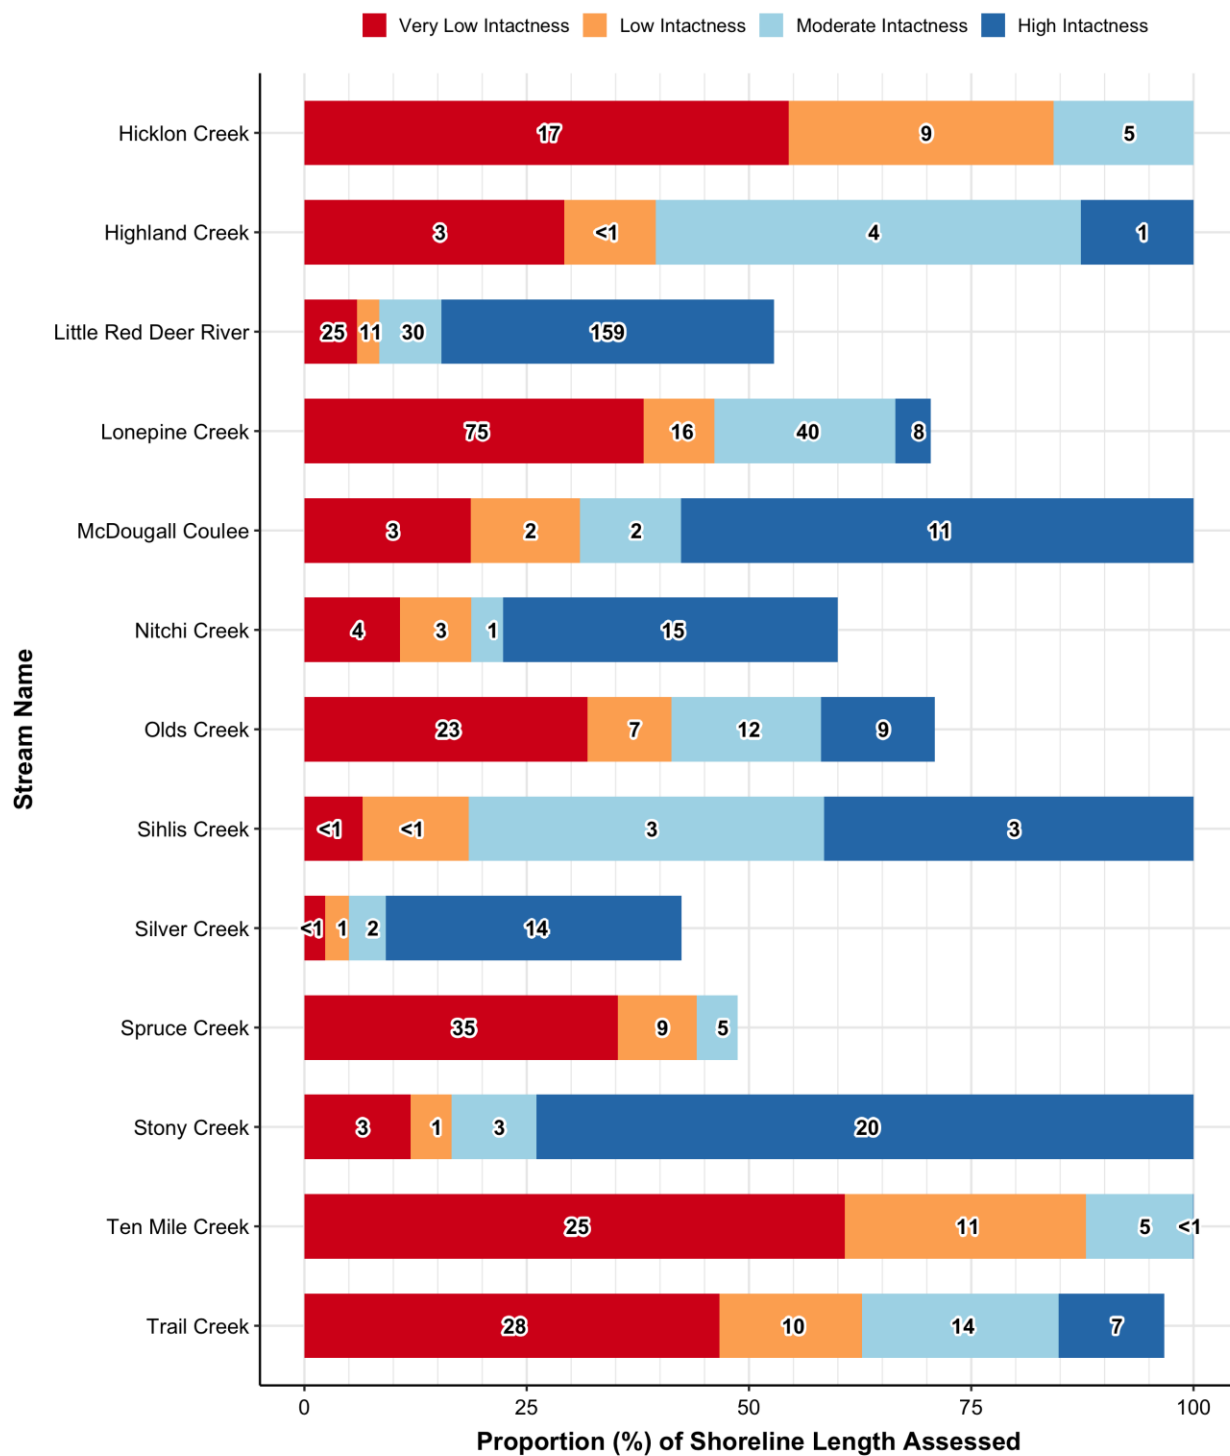
NOTE: Numbers indicate the total length (km) of shoreline associated with each intactness category.

Figure 49 *continued*. The proportion of shoreline length assigned to each riparian intactness category for named watercourses within Mountain View County.

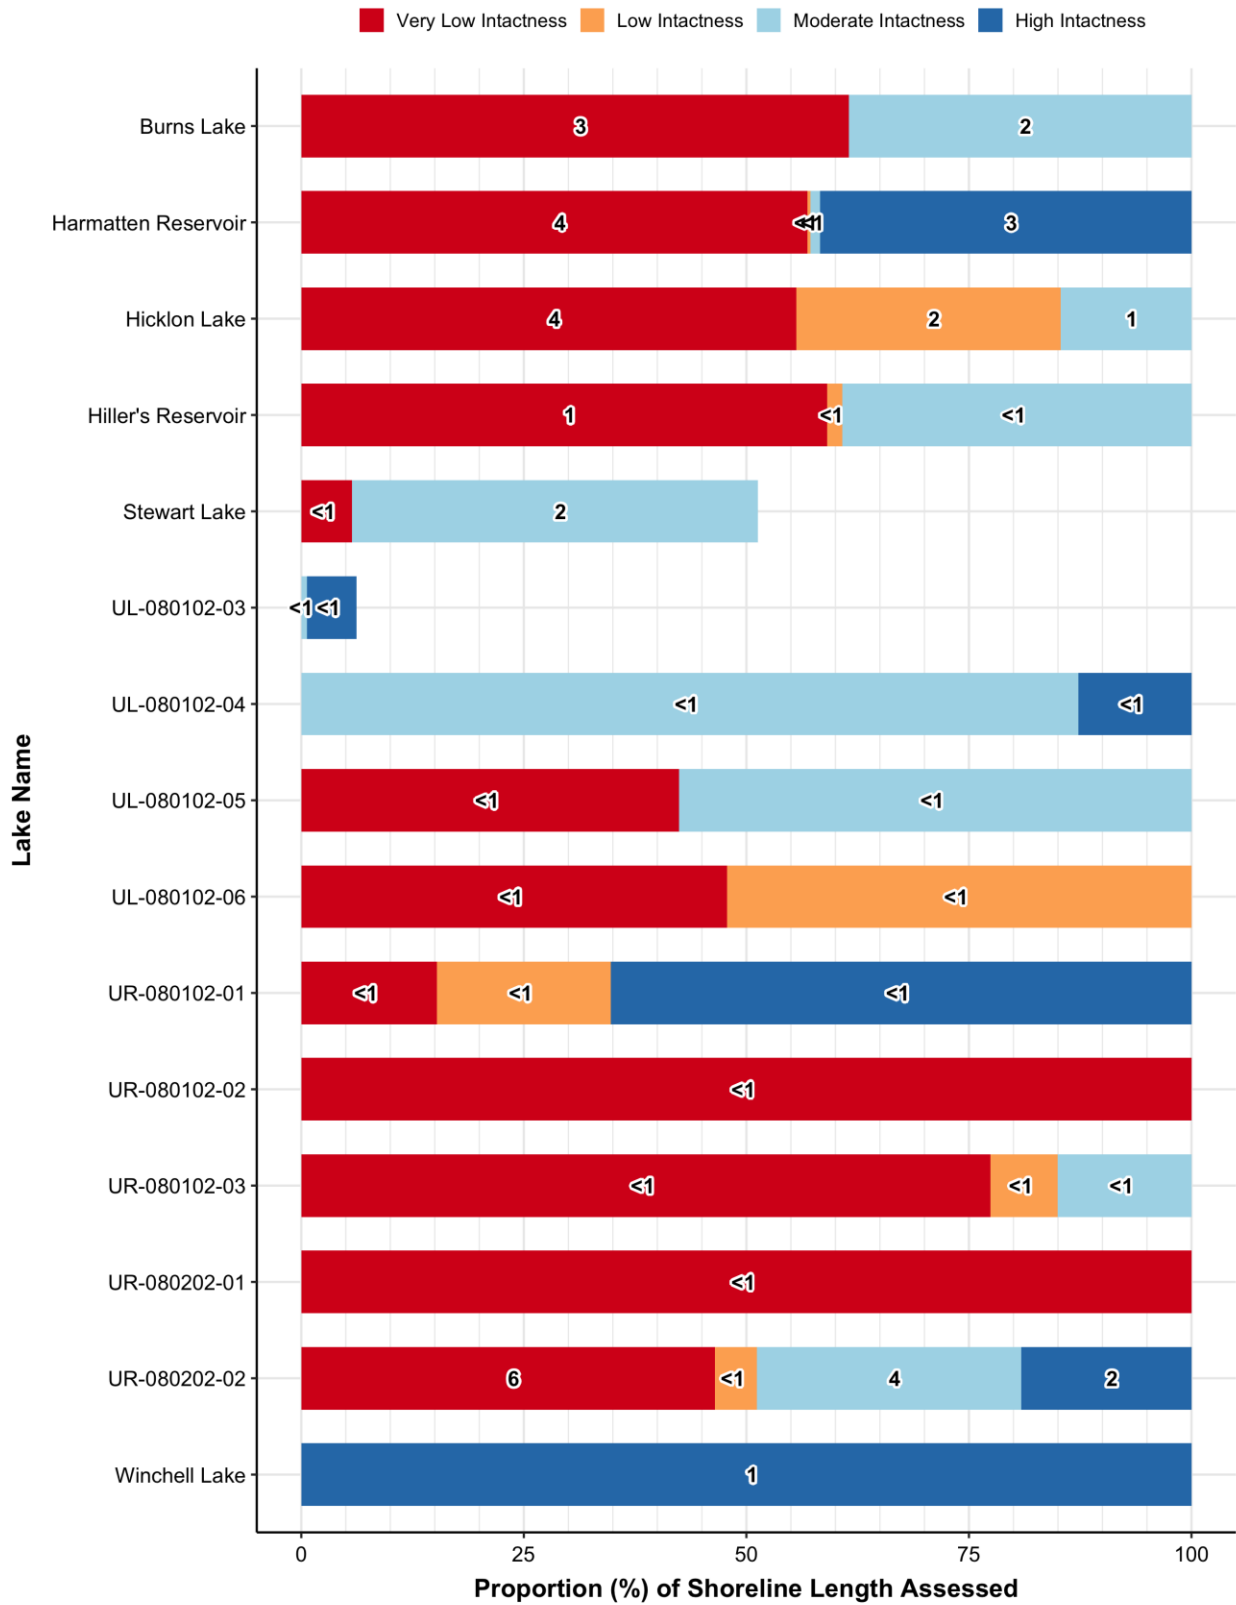
Figure 50. The proportion of shoreline length assigned to each riparian intactness category for named and unnamed lakes and reservoirs within Mountain View County.
